## Case Study: Air-con plant water pump shaft sealing

Cold water pump within air conditioning unit at a pharmaceutical plant in Brazil.

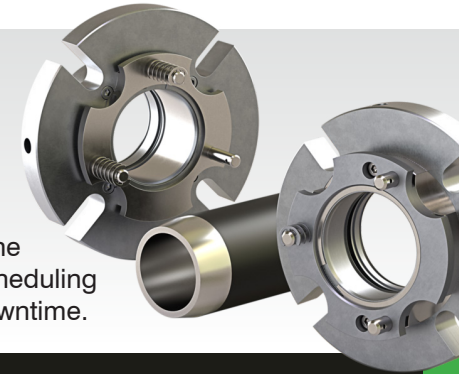
Replacement of mechanical seal with a KlickFix® cartridge containing six sequentially deployable sealing lips.

Stored lips are easily and quickly deployed when required and the pump put back on-line within seconds. This allows for simplified scheduling of maintenance and avoids unnecessary downtime.
