Case Study: Paper Mill Process Pump

Problem

Large paper mill facility in the US.

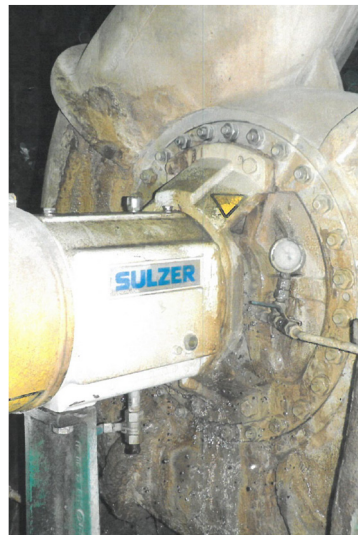
The customer was experiencing failures of casing cover bolts in service on average every 5-6 weeks. This created a lot of unnecessary downtime and led to rising maintenance and material costs. The root of the problem could be traced back to installation procedures, whereby the bolts on the casing cover were simply torque tightened.

Regular installation and service failure

- Sulzer process pump
- Mixing process creating excessive forces in the pump, transferring to the casing cover bolts

Existing bolts were replaced with RotaBolt® RB1 Touch, which accurately measures tension so that it can be correctly achieved, maintained and monitored and ensures that installation is not reliant on torque tightening. A quick and easy tactile check of the bolt load ensures that regular maintenance checks can be made during operation without incurring downtime of the process.

Since the introduction of RotaBolt® technology, the customer has eliminated the problem of bolts snapping during tightening. This is due to controlling tension during installation and using the RotaCap indicator to determine that the correct tension has been achieved, which ensures that the bolts do not suffer fatigue-fail as a result of vibration and transverse forces.
