Case Study:

Risk of repeat fires removed through flange management programme on a Texas Tower heat exchanger

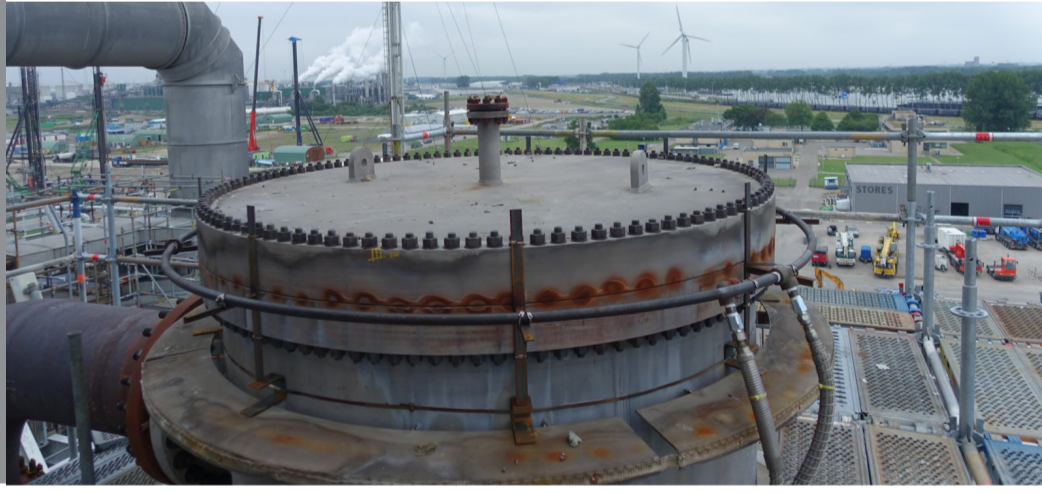
Texas Tower high temperature channel/shell and channel/channel cover flange connections were failing due to low bolt loads. High temperatures were causing flange rotation and graphite oxidation which in turn were leading to bolt relaxation and leakage. During installation it was found that bolt loads were not verified beyond basic torque tightening values. This ultimately led to the flange catching fire and requiring a steam quenching process to prevent further damage.

Catastrophic fire caused by joint relaxation

James Walker provided calculation support of the optimum bolt load for the joint. From this analysis it became evident the bolt diameter needed to be reduced from from 1 1/8" to 1" by the use of bolt collars. This would reduce the level of flange rotation under elevated temperatures.

Retaining Inconel® 718 was advised for bolt material, to maintain better creep resistance at the high operating temperature. Although, these bolts were further supported with RotaBolt® technology to ensure all bolts were tightened to the target bolt load.

To reduce the negative impact of graphite oxidation, the kammprofile gaskets were specified with APX-2 and SS321 materials. This reduced graphite oxidation and increased working life for the gasket. It is expected that these flange connections will now perform leak-free between turnarounds as a result of more accurate bolt tension and extended service life of the critical cover flange gaskets.
