Case Study:
Structural integrity of a cooling water impeller

Prototype cooling water system for a nuclear power plant.

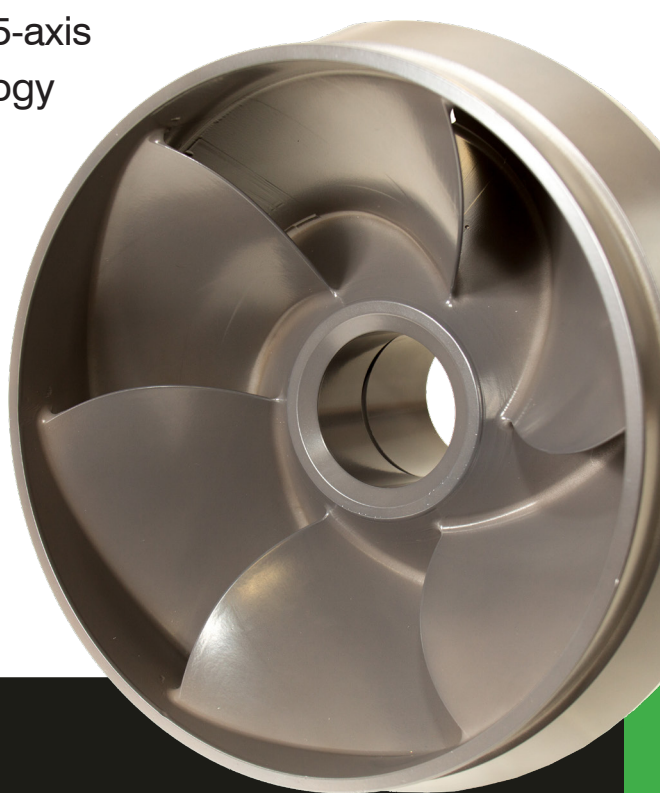
James Walker provided a turnkey solution as a way of simplifying the supply chain. We sourced the material and used 5-axis machining technology to machine a single-piece finished product from solid bar using the customer's existing drawings.

Switching from a welded assembly to machining from solid bar increased the tensile properties of the rotors and reduced the risk of failure associated with welding the rotor blades.

The change to a single machined component increased the strength of the impeller and allowed the customer to successfully test the application before the production piece was initiated.
