Successful sealing of problem flanges in high temperature / pressure applications

A technical paper
presented by
James Walker RotaBolt Ltd

Published in Valve World magazine
November 2012

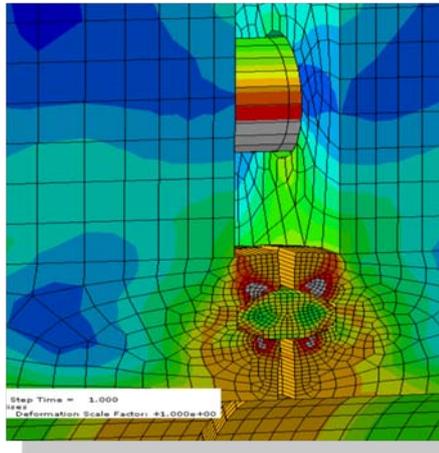
Figure 1 shows a simulation of the end of the tightening cycle, clearly demonstrating the seating stress being created between the RTJ gasket and the groove. The simulation assumes that all bolts were loaded to 234MPa bolt stress.

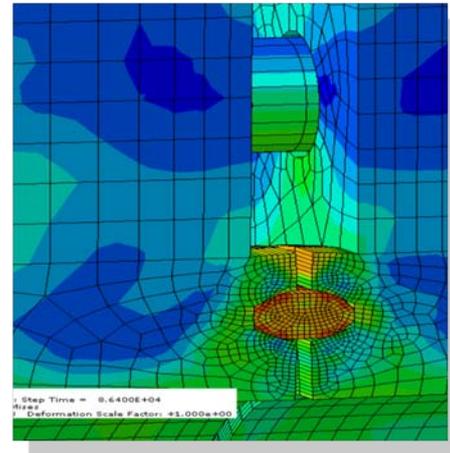
Figure 2 simulates what occurs after one thermal cycle from ambient through 380°C and back to ambient with the whole assembly pressurized to 80 Bar. During the heating up phase the seating stress of the RTJ gasket will rise due to the thermal growth of the assembly and plastic deformation between the RTJ gasket and groove could cause a catastrophic drop in bolt stress. There is only a narrow contact area between the RTJ gasket and groove in this type of flange assembly and the effects of thermal cycling have a critical effect on sealing performance.

As the assembly heats up, it was found that the thermal expansion of the stainless steel flange would be in the region of 1.5 times greater than the expansion of the B16 bolts. The effect of the difference in materials being further amplified by a significant temperature difference between the flanges and bolts. Typically, during heat up when the flange reaches an operational temperature of 280°C the bolts are still relatively cold at just 80°C.

Bolt stress therefore rises as the joint heats up and as a result seating stress between the ring type gasket and the RTJ groove also rises, to the point where plastic deformation occurs, in this case damaging the RTJ groove and compromising sealing.

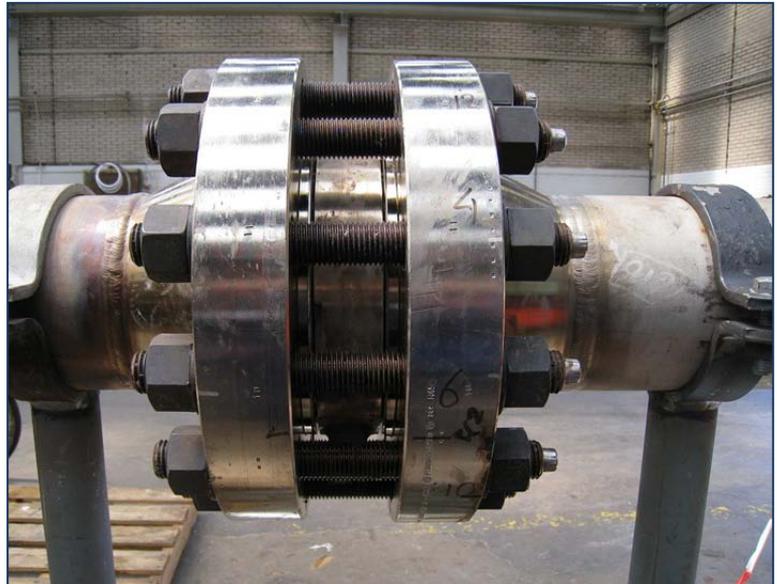
The rig was assembled using ring-type joints and bolts from standard suppliers and the flange secured using the recommended torque-tightening procedure. The joint was heated to 400°C and cooled back to ambient to simulate a typical process cycle. After cooling, a hydro test at 70 bar pressure was carried out to examine the load losses in the system, and the potential effect on sealing performance. After a single thermal cycle, the bolts were found to have lost tension and on disassembly the flange grooves were noted to have experienced some degree of deformation including damage to the groove recess flanks.

These tests confirmed what had been seen in the FEA modelling and explained what engineers were finding when dismantling flanges. In some cases, the cumulative flange damage had increased over the years to such an extent that the gap between the raised faces had almost disappeared. This of course adds to the risk that leaks may occur if the RTJ is not sufficiently compressed in service.

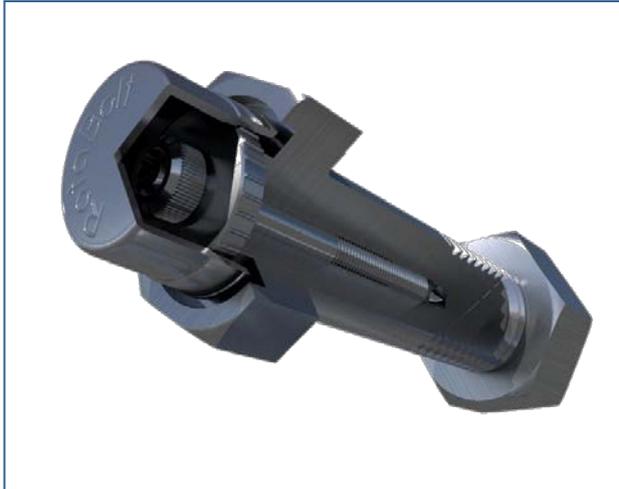
The RotaBolt[®] uses an internal mechanical strain gauge to monitor the tension achieved across the joint – a far more accurate method of bolting than traditional torque-tightening, which only gives an indication of the effort being put into tightening the bolt.

Each RotaBolt is individually 100% load test calibrated on installation, the rotating cap on the top of each bolt / stud locks when the correct tension is achieved and continues to provide a simple check of bolt tension in operation throughout the lifetime of the bolted joint. Should tension be subsequently lost for any reason, the cap will freely rotate.

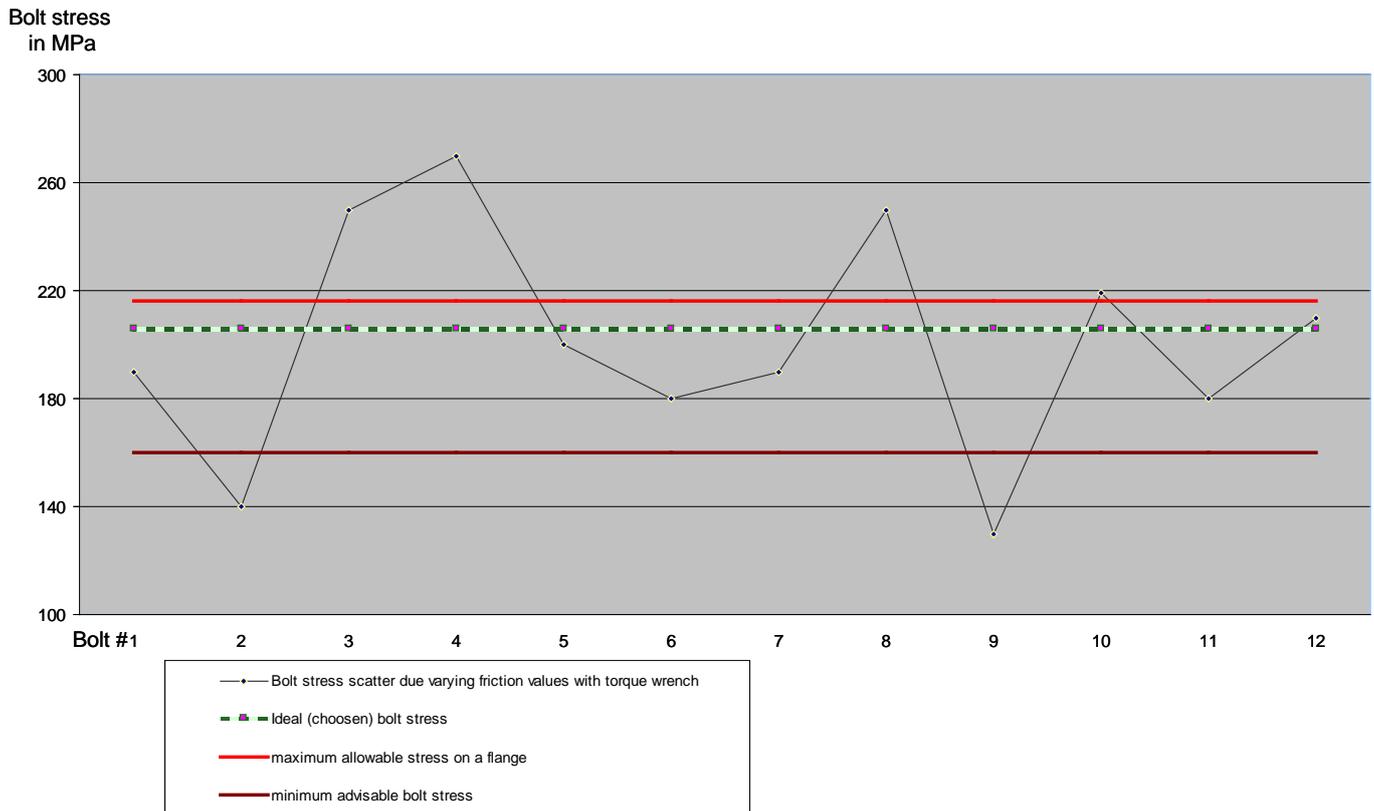
Bolt tension on installation

The chart below shows the results of a test carried out on 6" 900# RTJ flange that had been converted to the kammprofile solution. The aim of the test was to discover whether a tension control system was required during joint assembly in order to overcome bolt tension 'scatter' and achieve a bolt stress level within the bandwidth between minimum required and maximum allowable bolt load. The tightening method used for the test was torque control, afterwards measured with tension control.

When using standard B16 bolts and traditional torqueing on this 12 bolt flange only half the bolts were within the allowable range. This means that the joint is already subject to overload in some areas when the joint reaches the operating temperature, whilst at other points there is insufficient tension across the joint resulting in non-uniform compression of the kammprofile gasket. There is little chance of an effective seal across this joint after even a single thermal cycle as further bolting stress is lost. This could have a major impact on the time to leakage.

Using RotaBolts, the bolting stress on installation is evenly distributed and as close as possible (within $\pm 5\%$) to the ideal. Thus, before heating commences, the joint is starting from the optimum position. Although minor relaxation was observed on some bolts after cooling when using the Kammprofiles and RotaBolts (indicated by the fact that the caps could spin or were dragging), once the flanges were heated back up to their operating temperature, the target bolt tension returned again due to the thermal expansion difference between bolts and flanges (demonstrated by the RotaBolt caps locking once again).

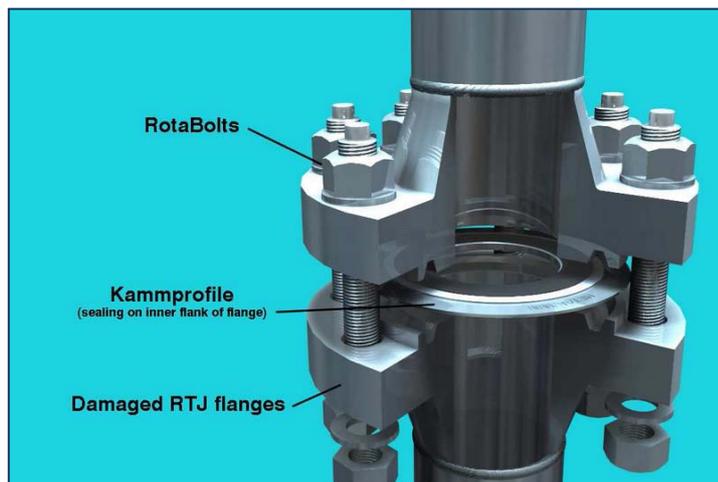
Adopting the kammprofile gasket option requires no work to be carried out on the flange grooves as the gasket seals against the undamaged flange faces 'inboard' of the RTJ groove, where there is more than sufficient available contact area between the inside diameter of the groove and the inside of the pipe. The kammprofile gaskets can easily be scheduled by taking into account the ring groove dimensions and pipe schedules employed.

As the gaskets operate at a high temperature the recommended facings are of very high purity graphite with an oxidation inhibitor which gives an improved high temperature performance over regular graphite grades.
