## Case Study: Paper mill process pump shaft sealing

Single stage centrifugal process pump within a paper and board mill in Canada.

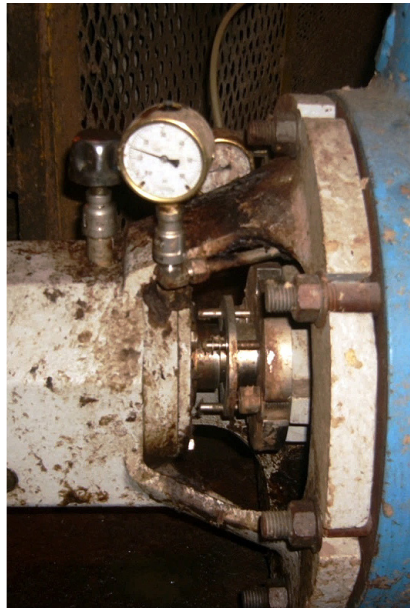
In an effort to assist the customer in reducing their costs and time spent on excessive cleaning and maintenance, a KlickFix® cartridge was installed. The cartridge uses a sequentially deployable sealing lip system to minimise downtime and eliminate the risk of catastrophic failure, which was a regular occurrence with the mechanical seal. The quick and simple process of utilising the stored lips in the cartridge would offer the

The KlickFix® unit has performed for over 3 years and 5 months leak free - an exceptional improvement to the previous solution.

In addition, the flush rate has been reduced using the KlickFix by 90% to less than 2 US gallons (7.57 litres) per hour.
