Case Study: Paper stock pump

Gould's 3175S centrifugal pump at a paper mill in America.

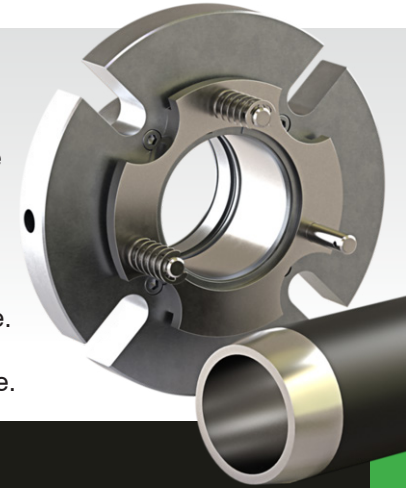
To overcome the existing issues, a KlickFix® cartridge fitted using the customer shaft sleeve with clean water flush was applied. The cartridge uses a sequentially deployable sealing lip system with six lips to eliminate the risk of catastrophic failure. The cartridge uses a sequentially deployable sealing lip system with six lips to eliminate the risk of catastrophic failure. Utilising the stored lips in the cartridge is a quick and simple process with minimal downtime.

The KlickFix® cartridge was installed and ran trouble free for ten months before clean flush water leakage was observed from the outboard side (not product), at which point the second sealing lip was then successfully deployed. Since the installation of KlickFix, the customer has massively reduced the health and safety risks associated with the previous sealing solutions.

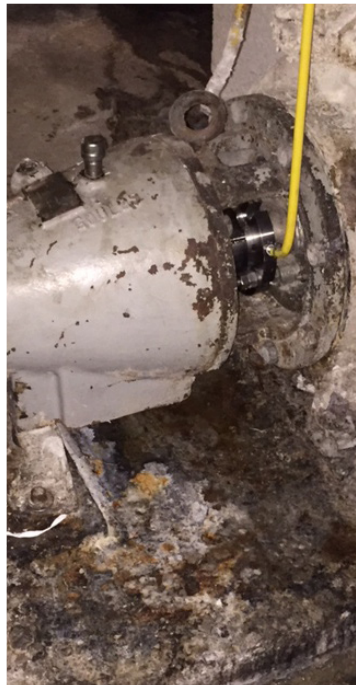
- Shaft diameter: 2.50" (63.50 mm)
- Shaft sleeve diameter: 3.00" (76.20 mm)
- Shaft speed: 800 ft/min (4.06 m/sec)
- Stuffing box pressure: 15 psi (0.10 MPa)
- Flush pressure: 25 psi (0.17 MPa)
- Media: white liner board stock
- Temperature: ambient
