## Case Study: Cryogenic ball valve seat seal

#### 3" Class 600 ball valve seat seal

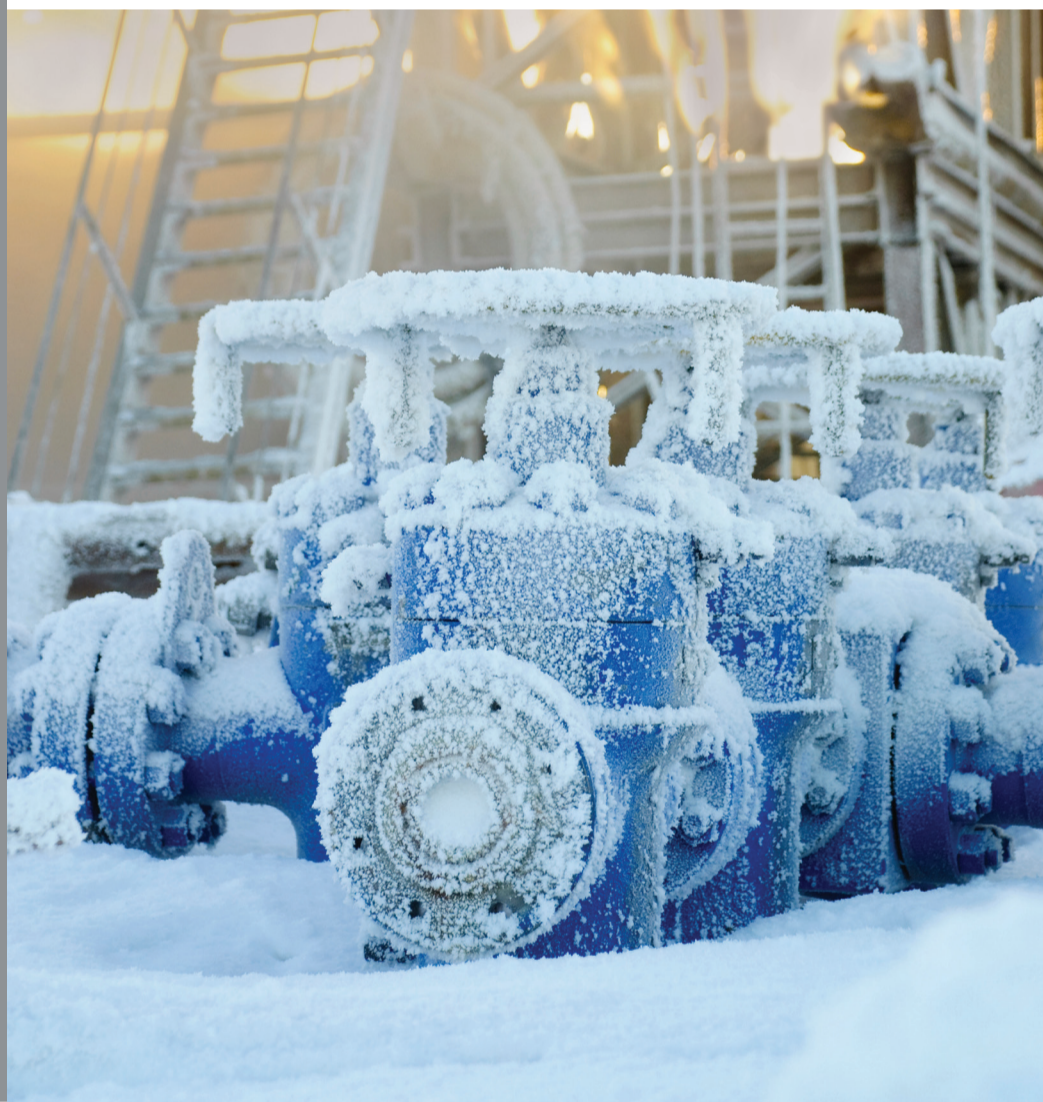
An asymmetrical Unilion<sup>®</sup> J01 lip seal configuration was recommended and installed to counteract performance inconsistency for this critical service. This was provided in our Fluolion<sup>®</sup> 22 modified PTFE jacket sealing material, along with double heat-treated cobalt chromium alloy helicoil springs to ensure seal force was optimised.
